## Inspection Report

**Mr. and Mrs. John Doe**

111 Smith St  
Anytown MI

### **Caverley Home Inspections**

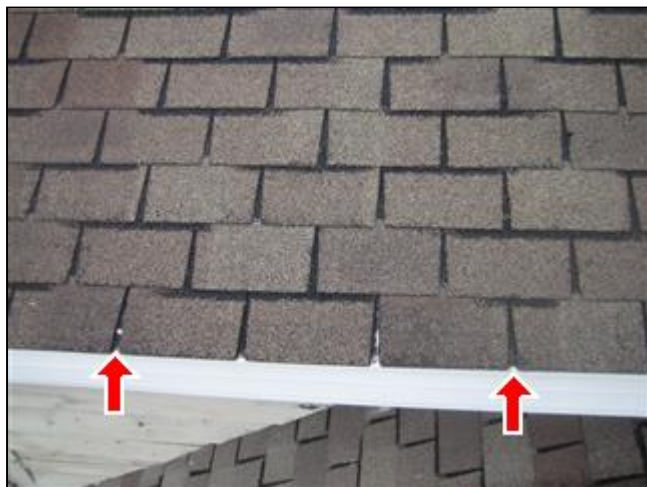
1.0 Item 1(Picture)

These shingles are 21 years old. They are 25 year shingles, and are towards the end of their life expectancy. Some areas at the drip edge on the front dormer, the first layer of shingles are deteriorating. I would recommend repairing these areas if the buyer intends to keep these shingles in place for a few more years.

The buyer should expect to replace the roof in the next 5 years.

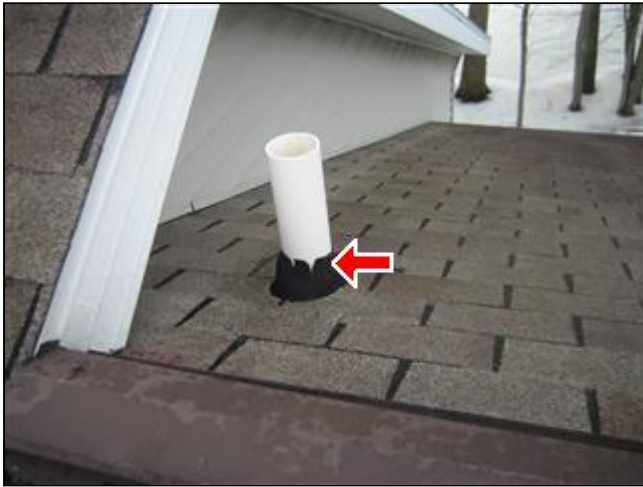
1.1 Item 1(Picture)

The flashings around the PVC vent pipes are badly cracked and should be replaced. A small amount of moisture was seen on one of the pipes in the attic. Additional leakage could occur if these are not replaced.

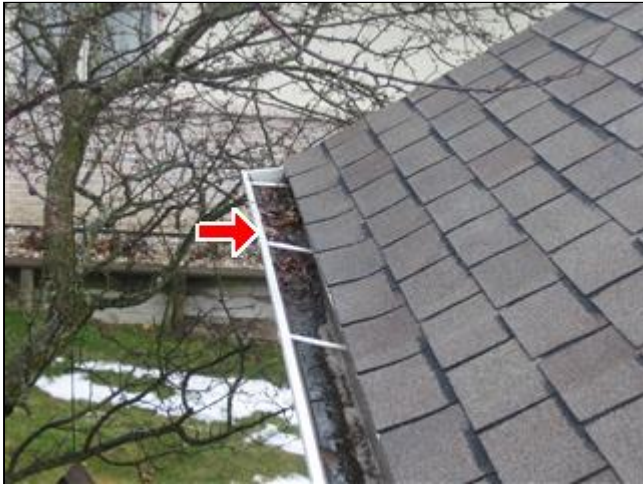
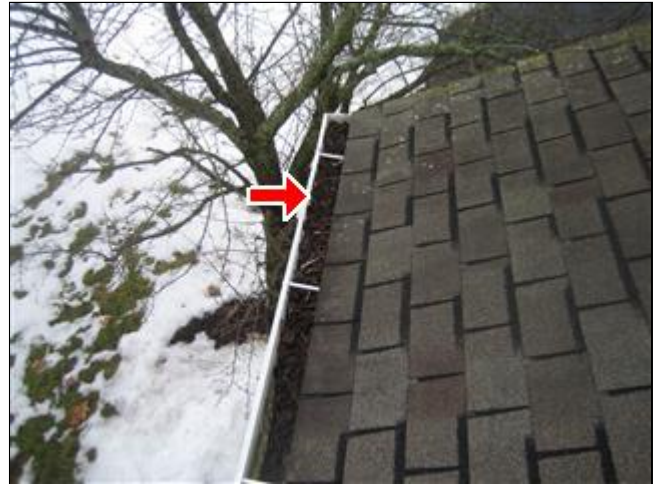
1.3 Item 1(Picture)

Gutters on both corners on the front of the home should be cleaned of leaves and debris to allow for proper drainage. Overhanging limbs on each corner should be trimmed back to keep leaves from collecting in the gutters.

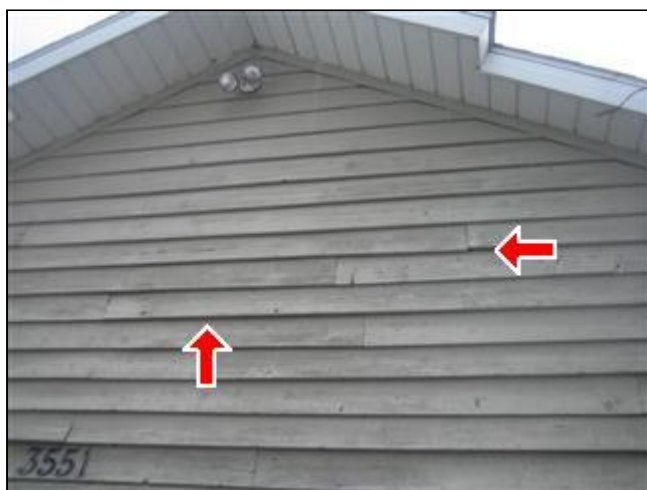
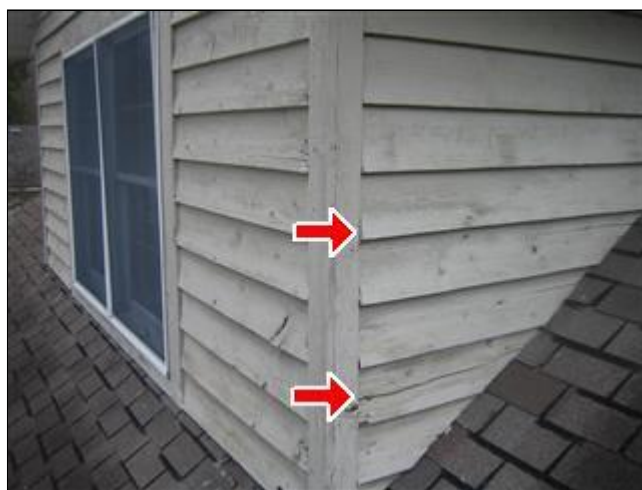
2.0 Item 1(Picture)

There are some areas on the front garage gable, and the dormer on the front roof, where the wood siding is loose. Fasten with galvanized siding nails.

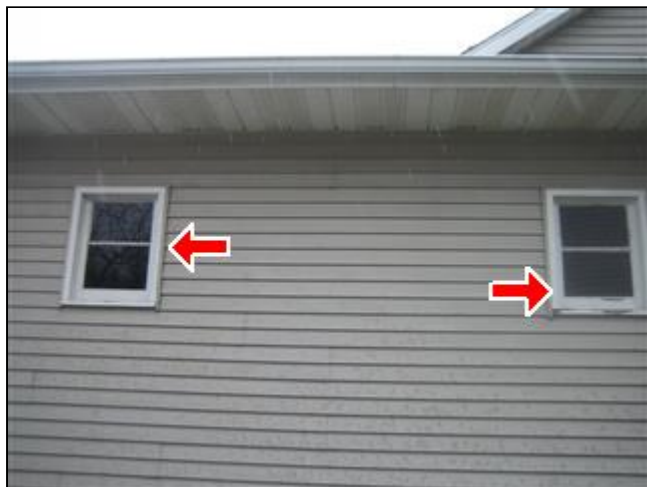
2.1 Item 1(Picture)

I would recommend cleaning and painting the jambs and trim on the service door from the garage to the east side deck, to keep the wood from deteriorating. Also, clean and paint the wood windows on the east side of the garage to prevent premature deterioration.

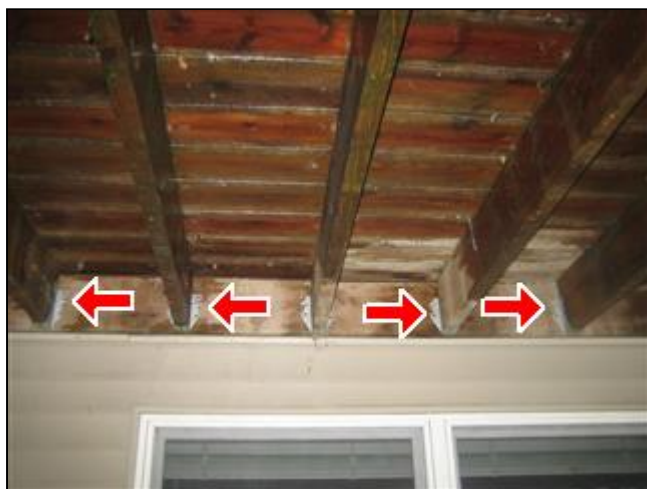
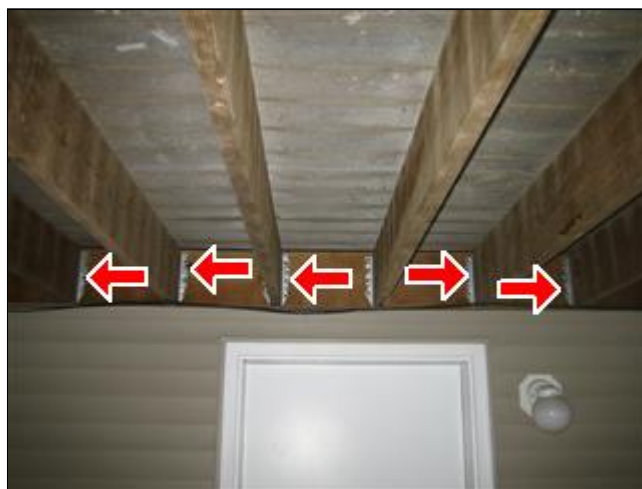
2.3 Item 1(Picture)

The nails used to fasten the joist hangers to the rim on the house on the upper east and west decks are not galvanized. This could result in the nails rusting through, and causing the connection to fail. Add galvanized joist hanger nails in these areas.

The rim joist should be connected to the home with lag bolts or structural screws. Presently, nails are being used.

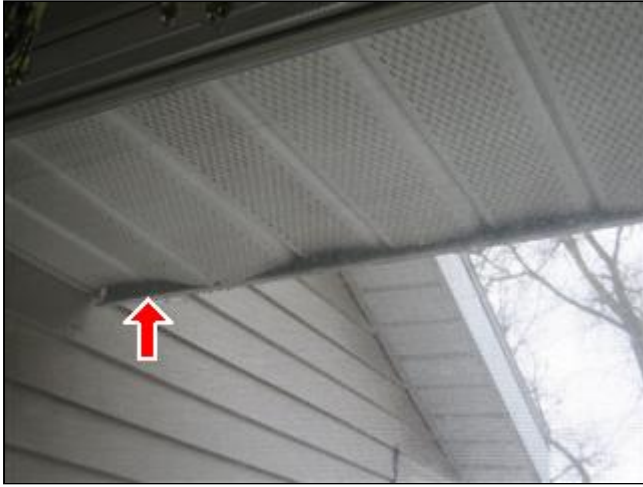
2.5 Item 1(Picture)

The fascia on the upper south roof outside of the second floor sitting area is loose. Fasten as needed to secure fascia.

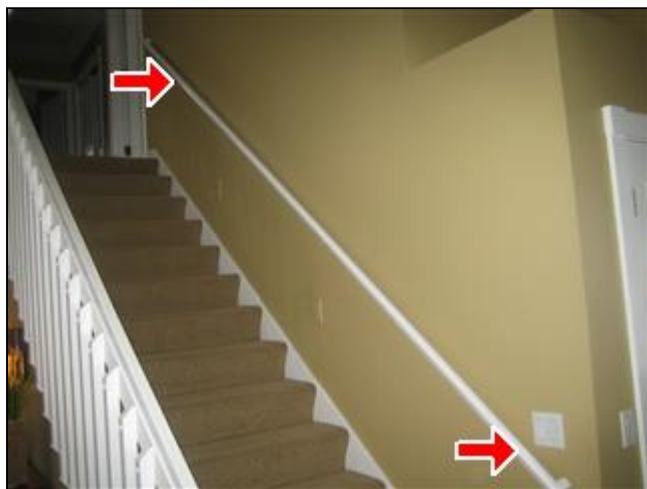
4.3 Item 1(Picture)

The railing going up to the second floor is loose. Secure as needed.

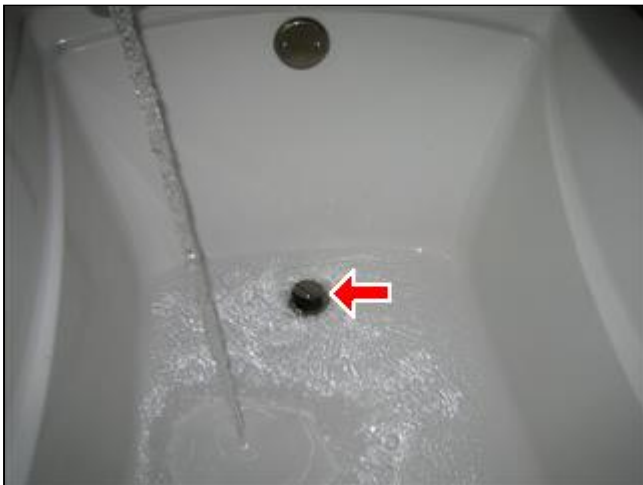
6.1 Item 1(Picture)

The drain stopper in the master bathroom soaking tub is broken, and should be replaced.

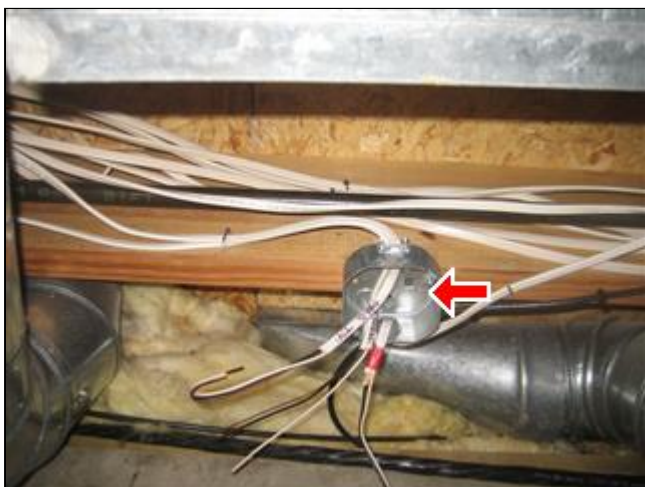
7.3 Item 1(Picture)

There is a electrical junction box with loose wires above the breaker panels. These wires are not hot, and appear to have been run for future electrical to the media room.

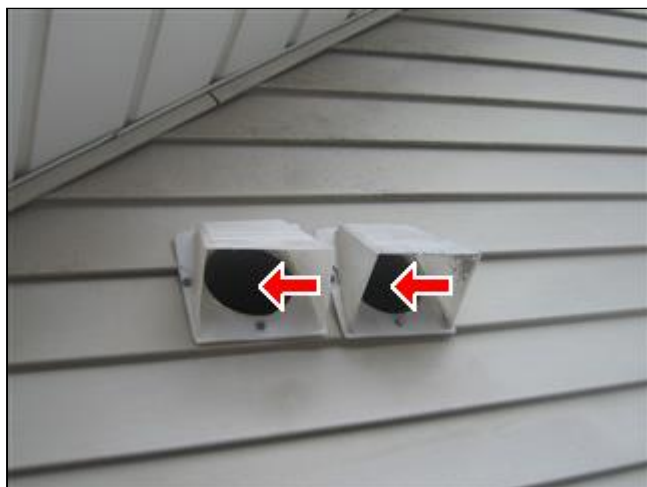
9.4 Item 1(Picture)

The flaps are missing on the vents for the exhaust fans on the east gable. This would allow cold to flow back to exhaust fans. Replace vents.

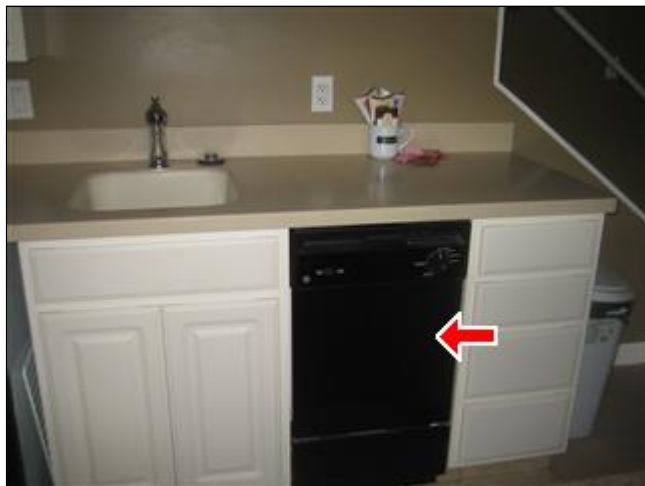
10.0 Item 1(Picture)

The water for the dishwasher in the lower level would not start. Contact a qualified repairman to correct the issue.

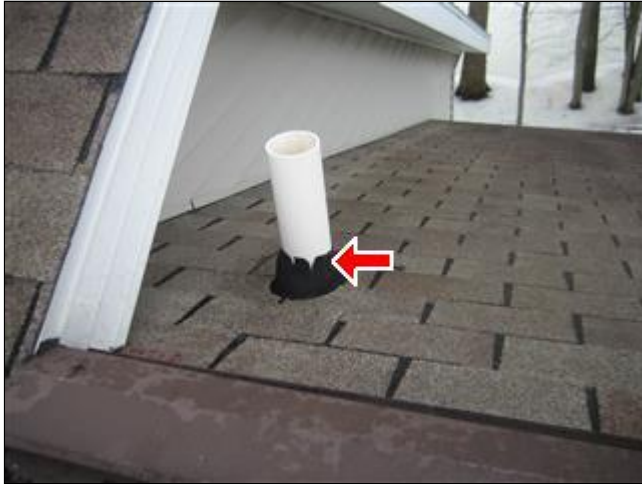
1.1 Item 1(Picture)

The flashings around the PVC vent pipes are badly cracked and should be replaced. A small amount of moisture was seen on one of the pipes in the attic. Additional leakage could occur if these are not replaced.

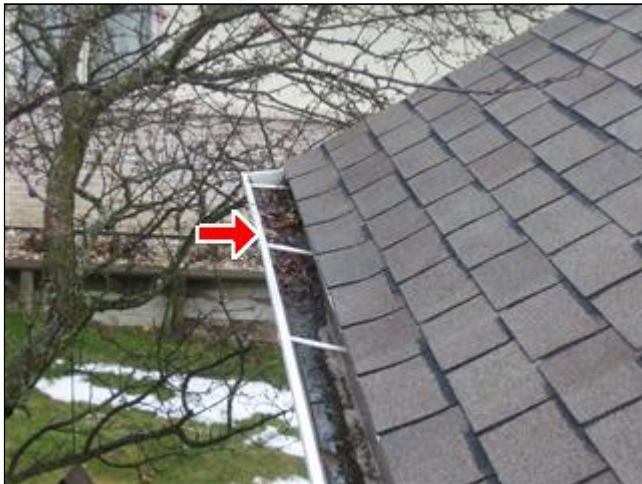
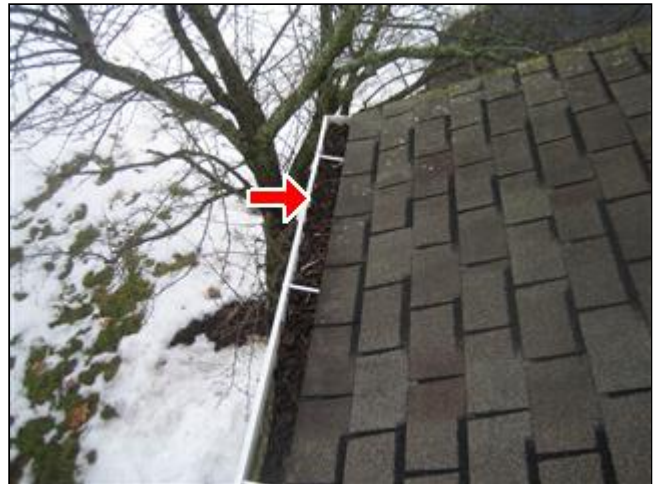
1.3 Item 1(Picture)

Gutters on both corners on the front of the home should be cleaned of leaves and debris to allow for proper drainage. Overhanging limbs on each corner should be trimmed back to keep leaves from collecting in the gutters.

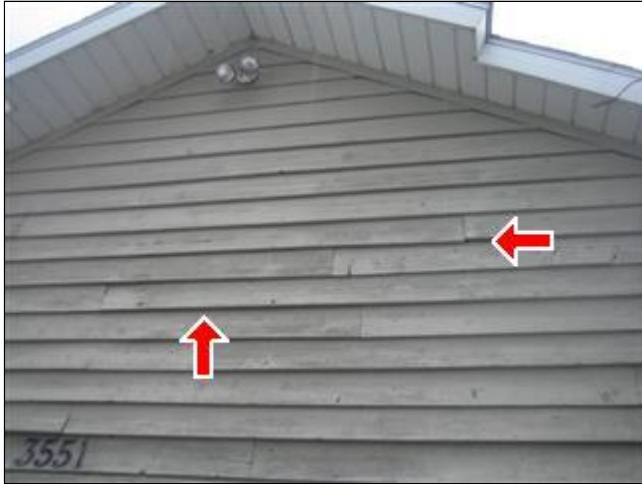
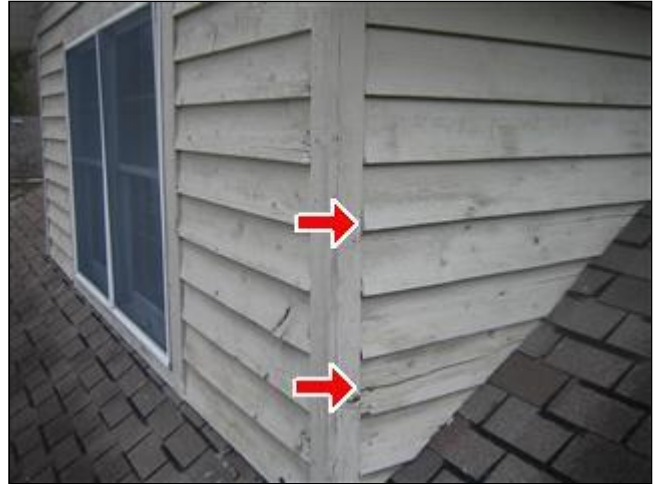
2.0 Item 1(Picture)

There are some areas on the front garage gable, and the dormer on the front roof, where the wood siding is loose. Fasten with galvanized siding nails.

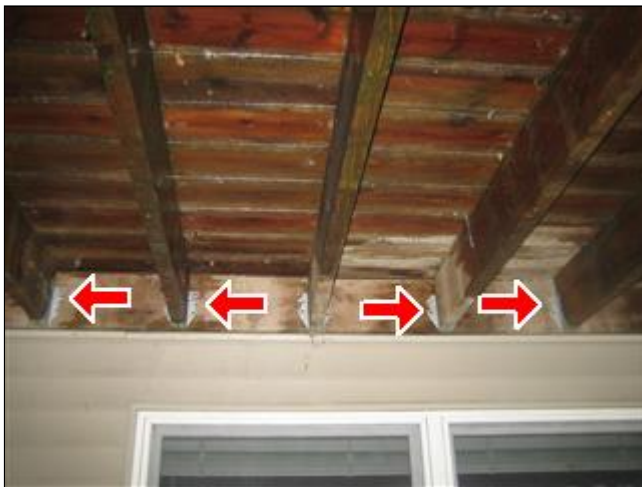
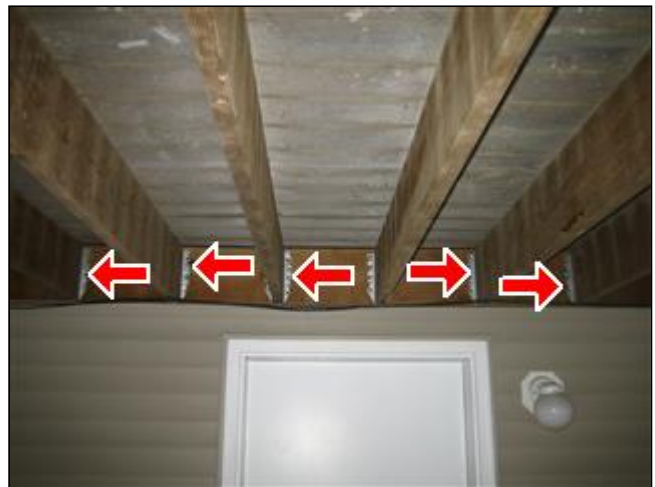
2.3 Item 1(Picture)

The nails used to fasten the joist hangers to the rim on the house on the upper east and west decks are not galvanized. This could result in the nails rusting through, and causing the connection to fail. Add galvanized joist hanger nails in these areas.

The rim joist should be connected to the home with lag bolts or structural screws. Presently, nails are being used.

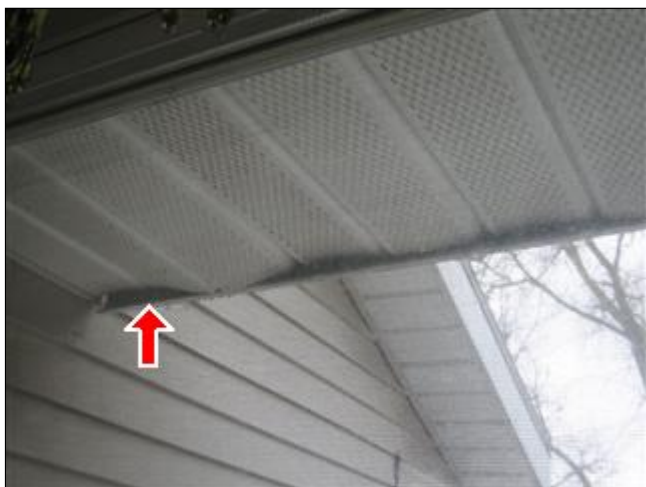
2.5 Item 1(Picture)

The fascia on the upper south roof outside of the second floor sitting area is loose. Fasten as needed to secure fascia.

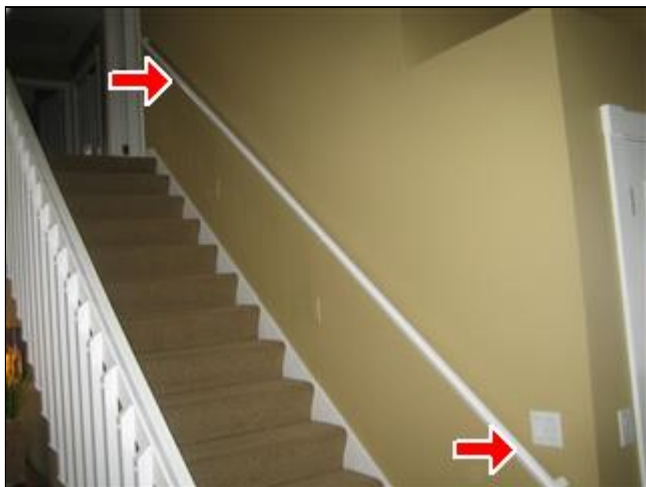
4.3 Item 1(Picture)

The railing going up to the second floor is loose. Secure as needed.

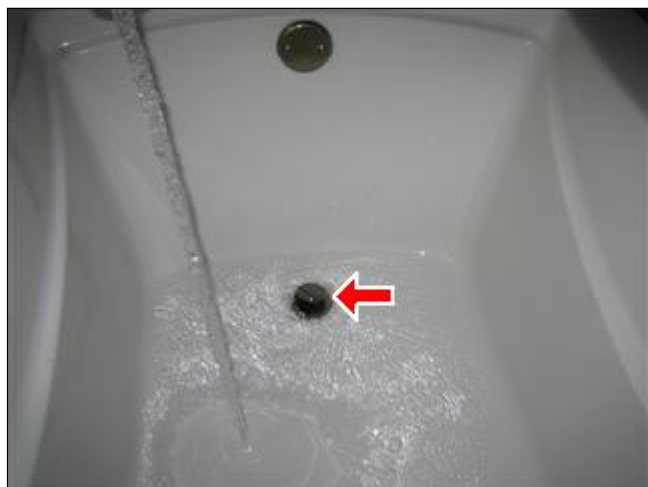
6.1 Item 1(Picture)

The drain stopper in the master bathroom soaking tub is broken, and should be replaced.

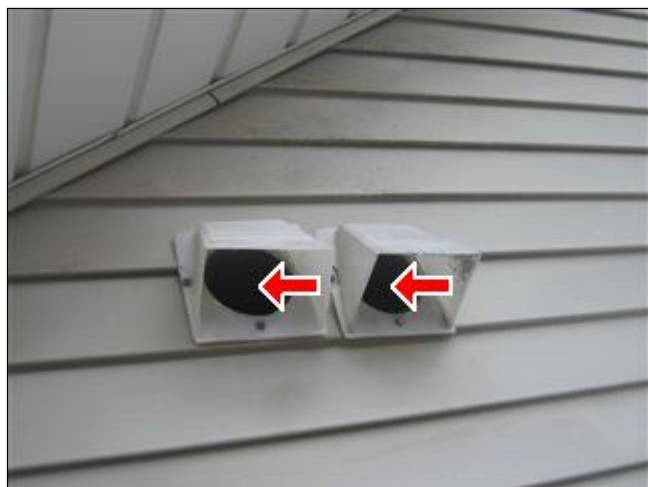
9.4 Item 1(Picture)

The flaps are missing on the vents for the exhaust fans on the east gable. This would allow cold to flow back to exhaust fans. Replace vents.

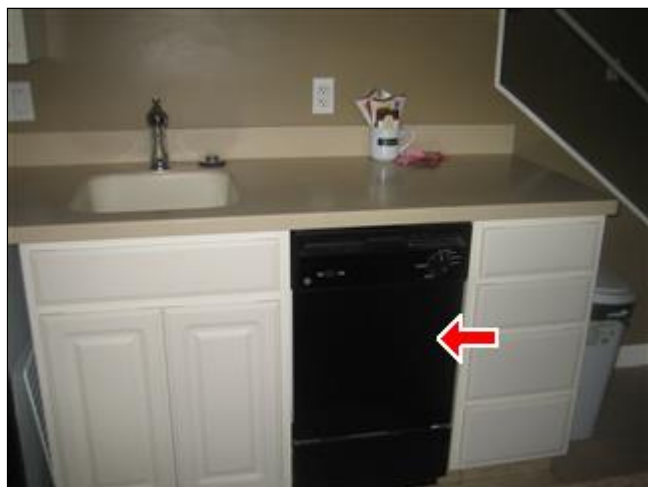
10.0 Item 1(Picture)

The water for the dishwasher in the lower level would not start. Contact a qualified repairman to correct the issue.
